Mattapoisett Land Trust, Inc.

Habitat Restoration Plan for the Mattapoisett Salt Marshes Initial Technical Review Meeting, November 17, 2023 Mattapoisett Fire Station Training Room, 62 County Road (Rt. 6), Mattapoisett

Mattapoisett Neck Habitat Restoration Plan

Technical Review Meeting

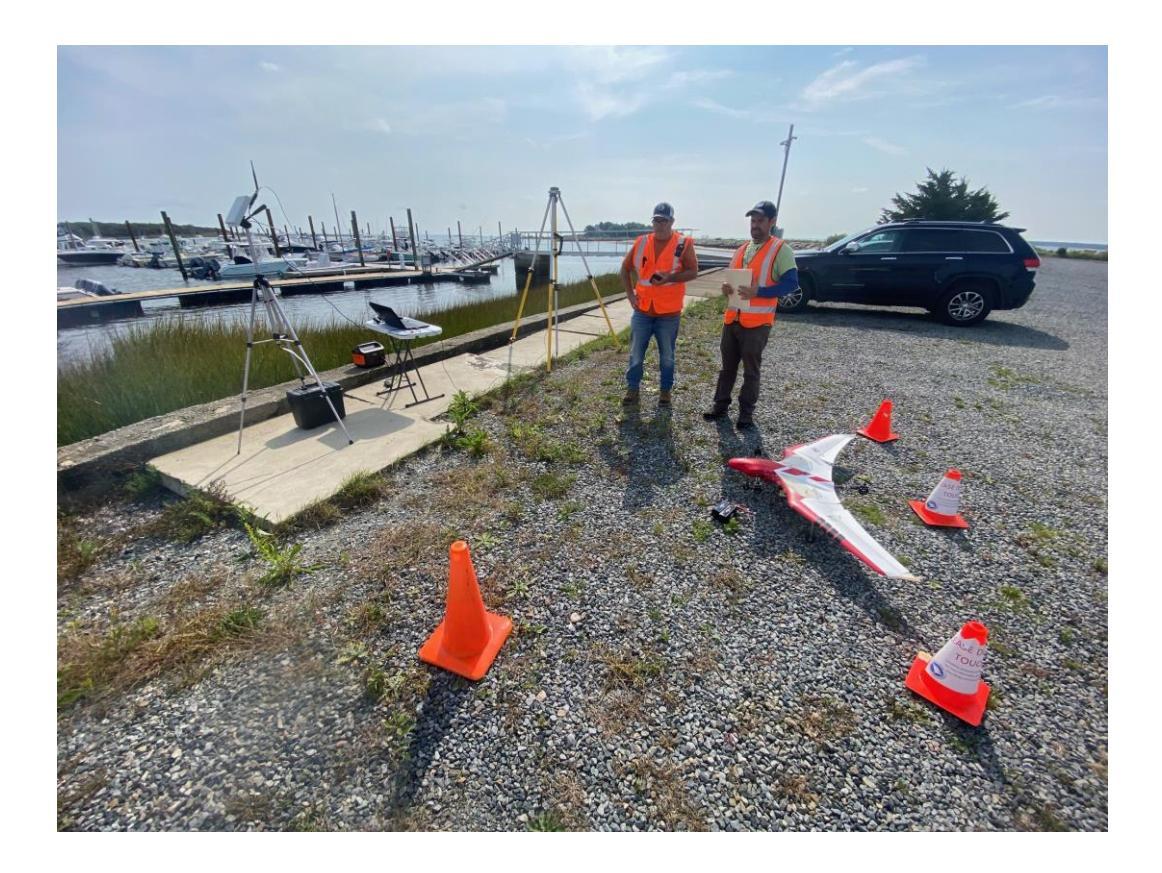
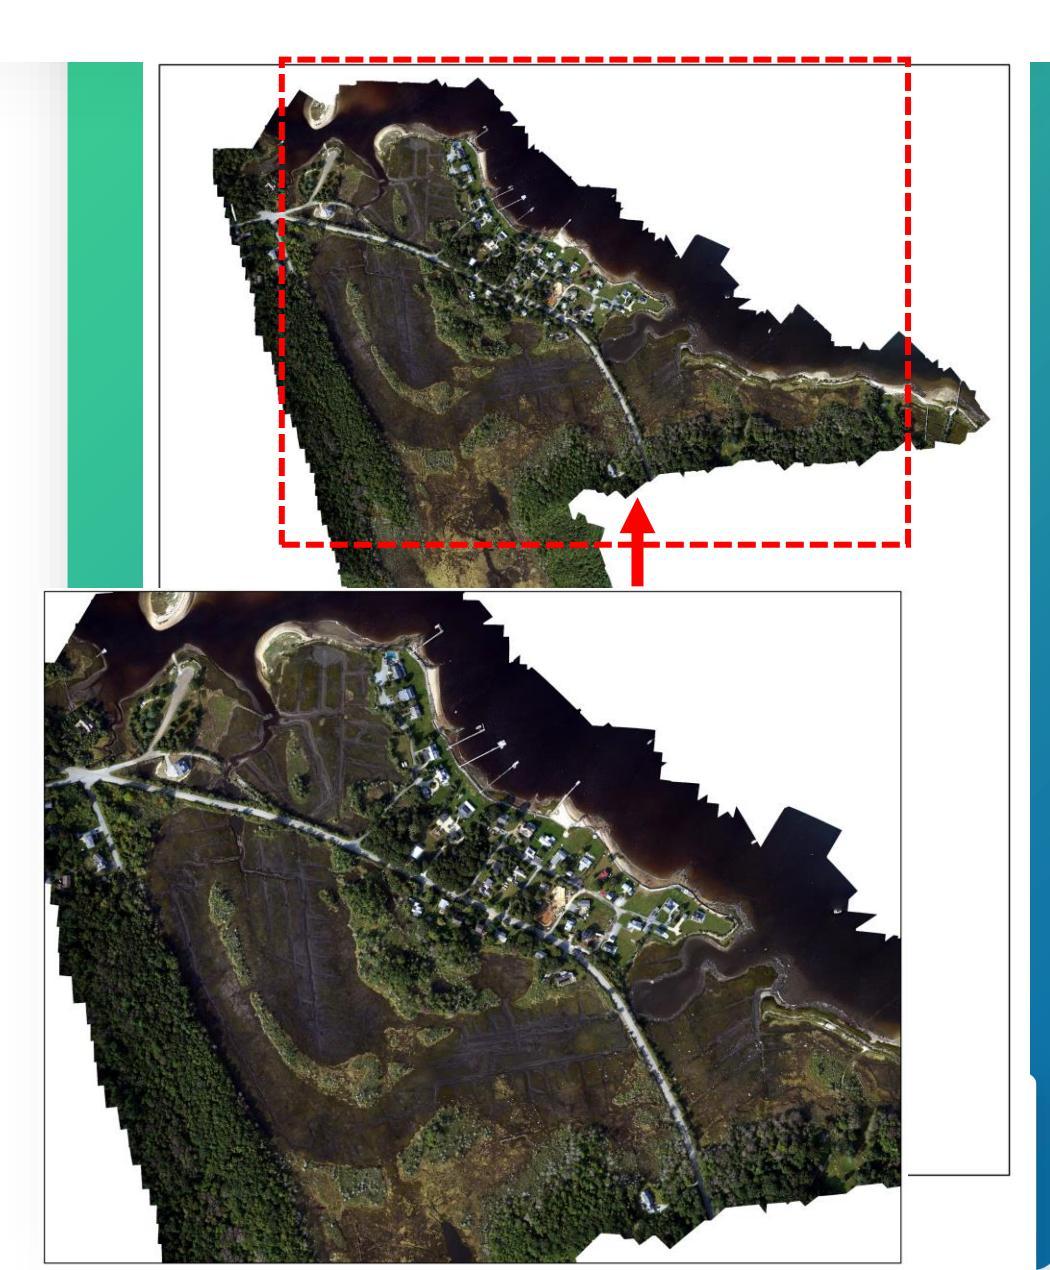
Aerial Drone Survey

- September 28, 2023
- Facilitated by Center for Coastal Studies
- Photogrametric Approach

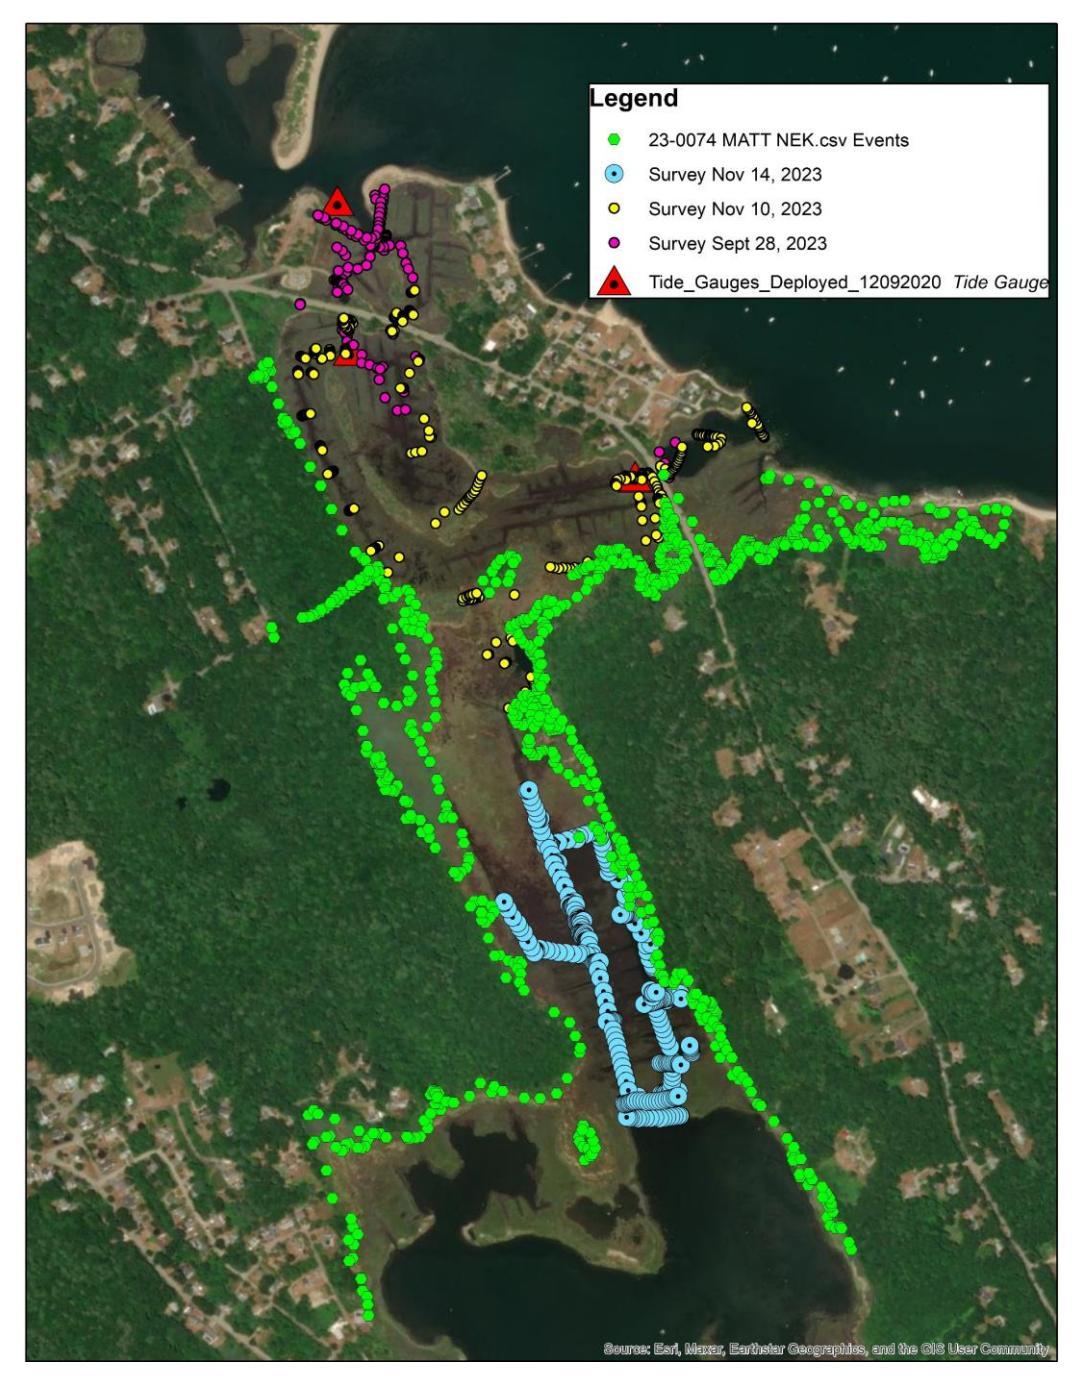
Topographic Survey

- Confirmatory measurements to ground truth drone data
- Survey Grade Real Time Kinematic (RTK) GPS Unit
- Collected survey data from marsh surface, channels, and shallow bathymetry (wading)
- Datums: Massachusetts State Plane Mainland (feet) and NAVD88 (feet)

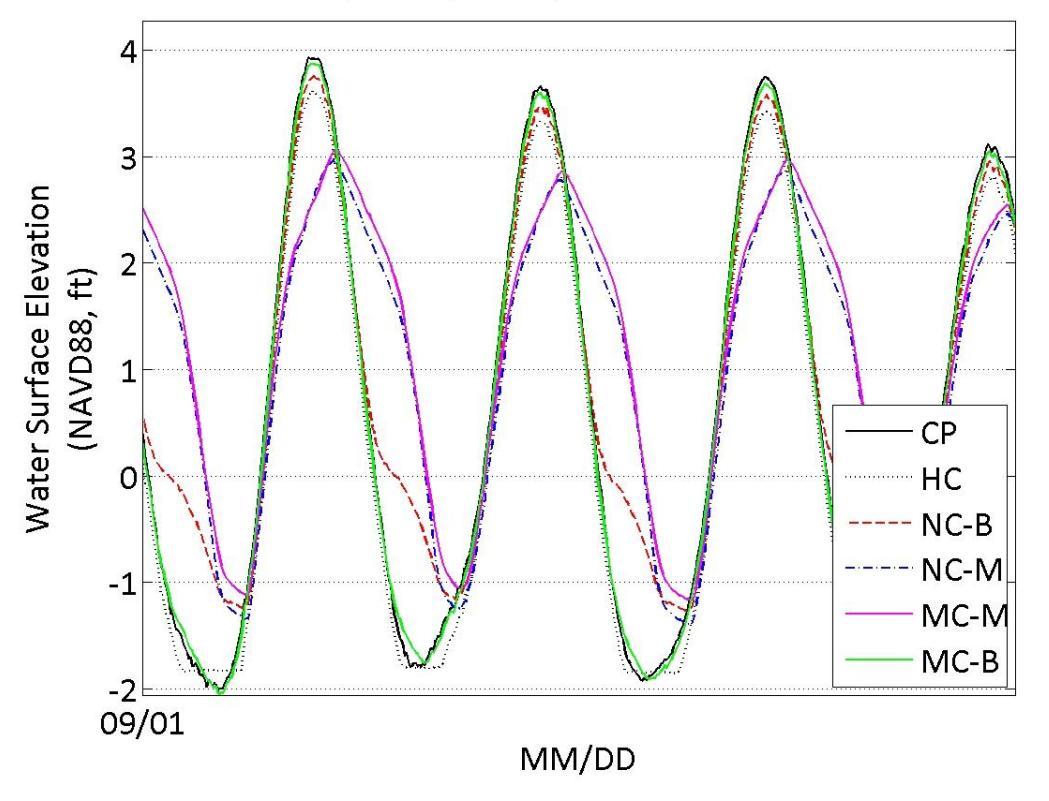
Tide Study

- Deployed six (6) water level (tide) gauges for 30 days
- Gauges deployed either side of each culvert
- One each in Harbor & Hammonds Cove
- Salinity at one station

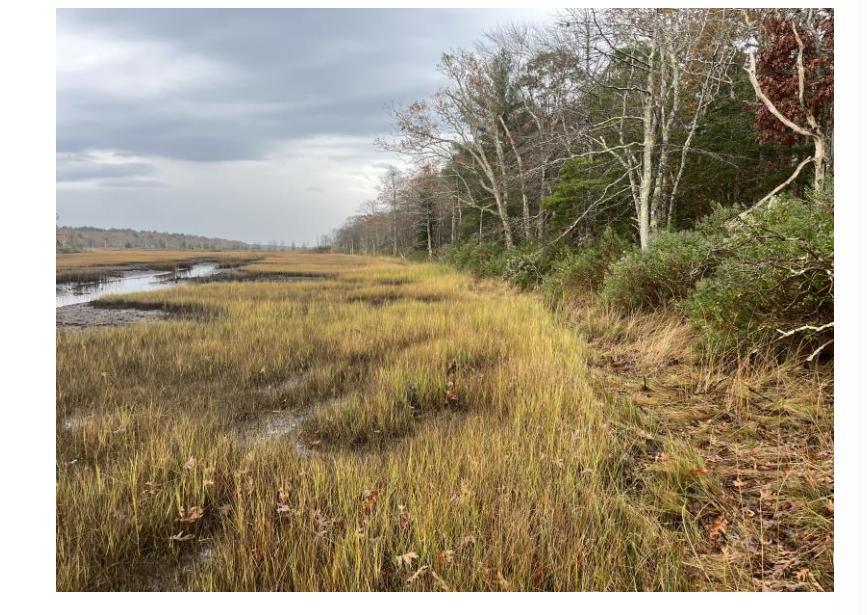
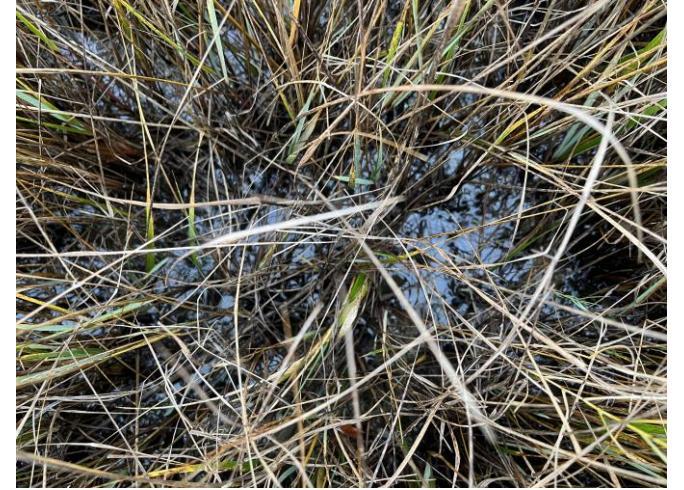
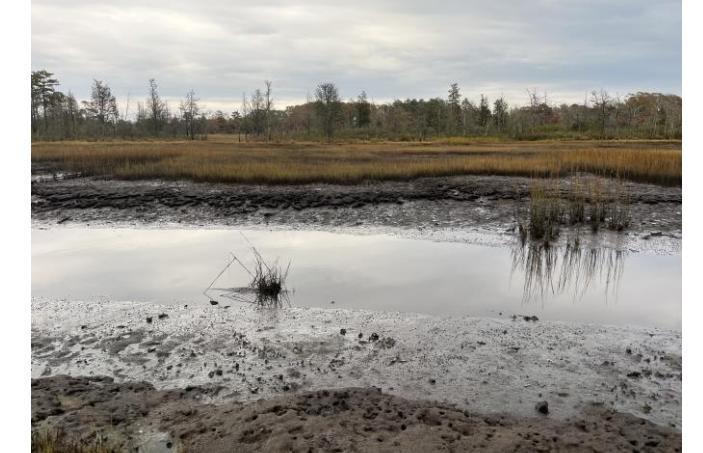
1) Document Existing Conditions

- Low-grow S. alterniflora
- Low-lying coastal bank
- Regular BVWs

2) Identify Key Stressors

- $\circ~$ Saturated marsh plain
- Groundwater inputs
- $\circ~$ Infilled channels

Numerous Hummocks

Infilled Channel

Groundwater Inputs

> Groundwater Inputs

Dieback

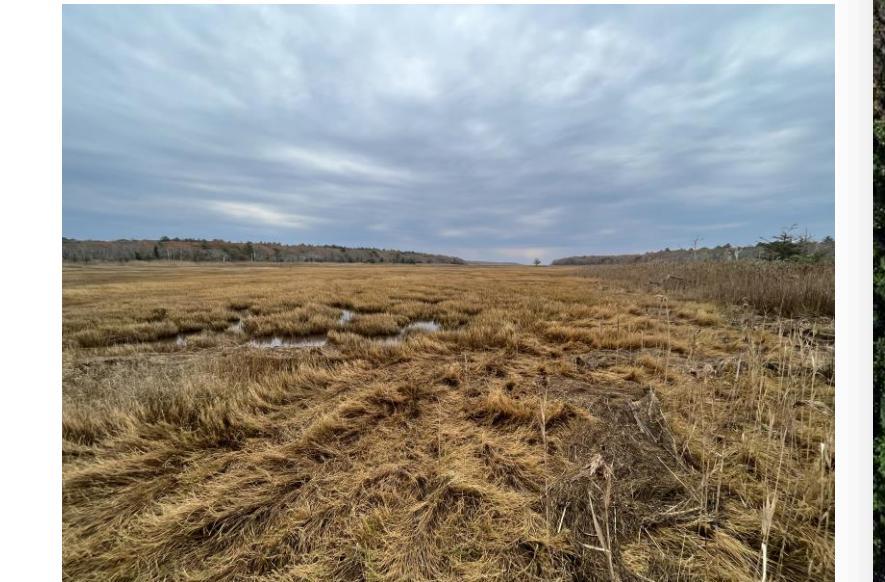
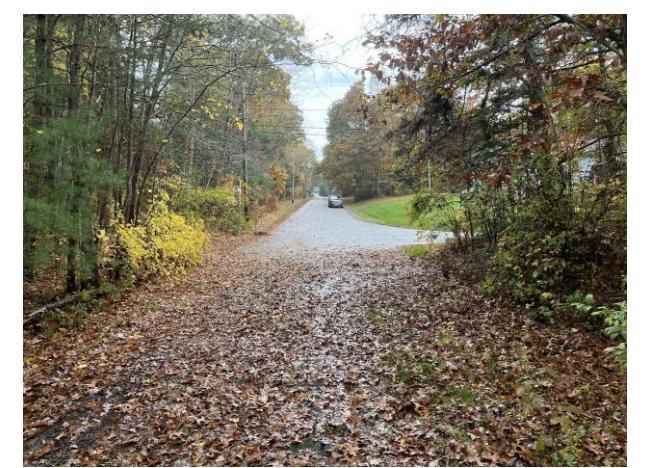
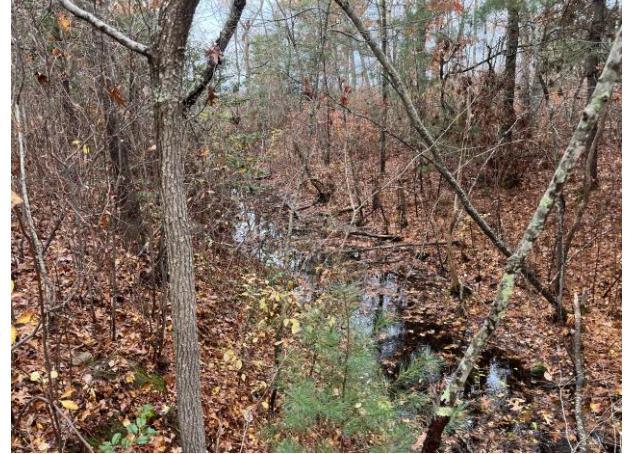
- Numerous Hummocks
- Direct Streamflow
- North = Low Marsh
- South = High Marsh

- \circ Nutrients
- Stormwater Impacts
- Invasive Species

Outfall / Streamflow

Little impediment to tidal flow

Extensive Phragmites High Marsh

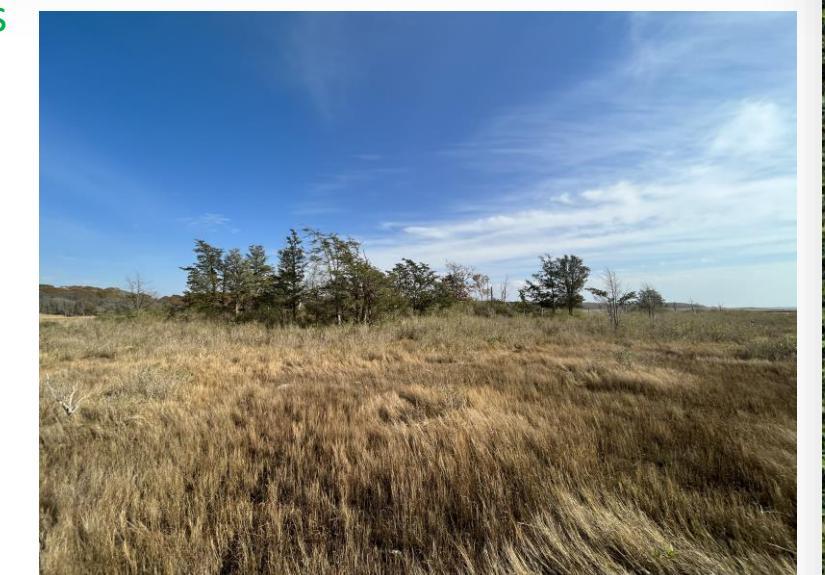
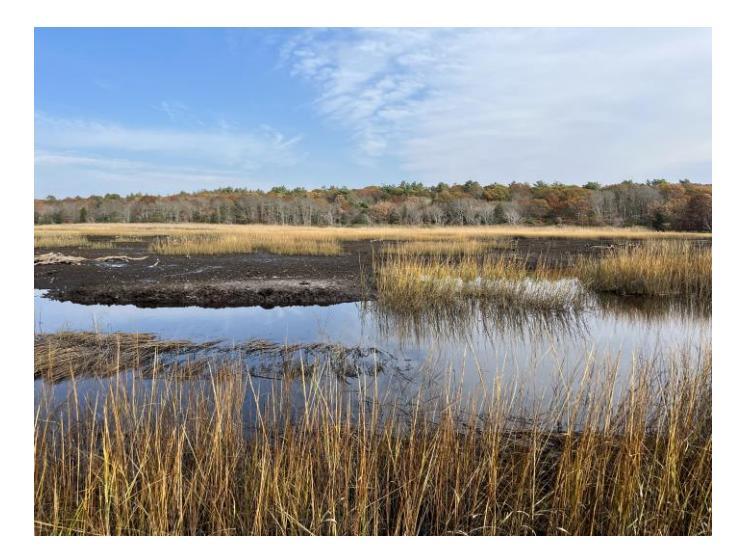
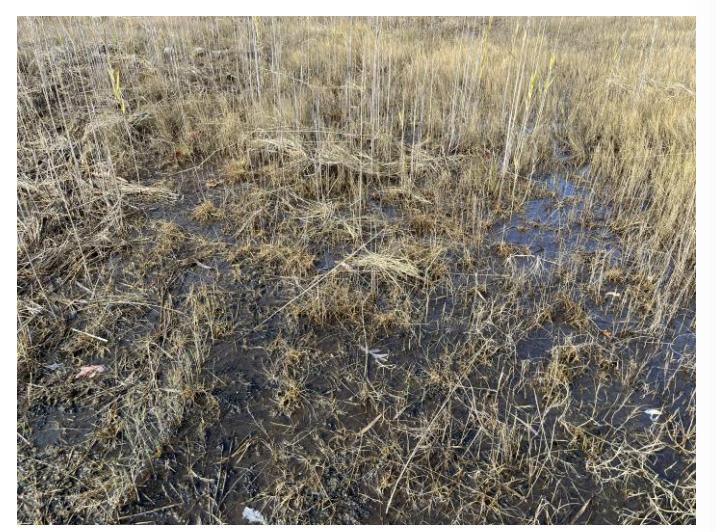
- Variable Marsh Condition
- Numerous BVWs
- Expansive Mudflat

- $\circ~\mbox{Supersaturation}$
- $\circ~$ Stunted Vegetation
- $\circ\,$ Channel Infilling

Supersaturated Marsh Surface

Channel Infilling

Streamflow

Persistent Upland Vegetation

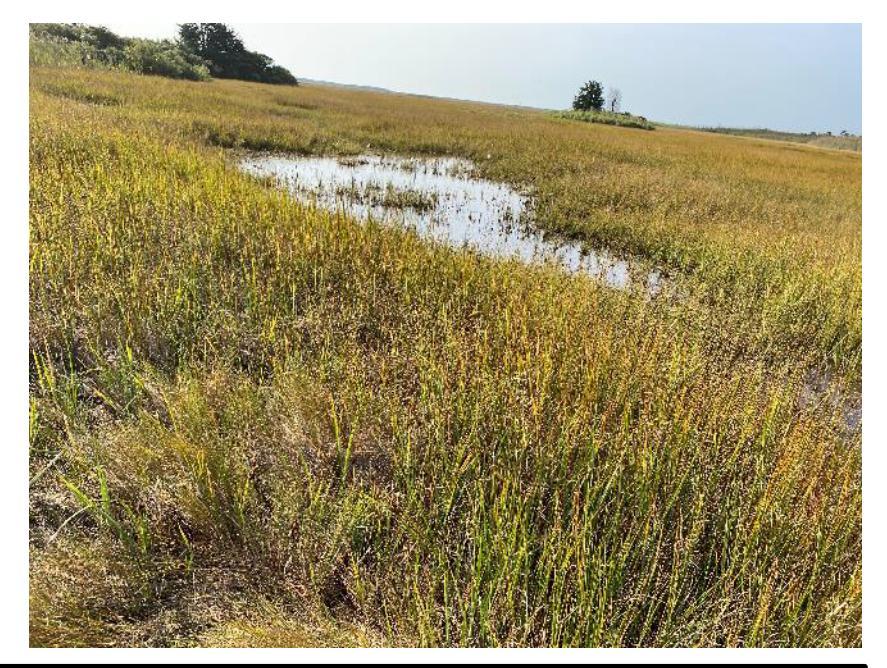
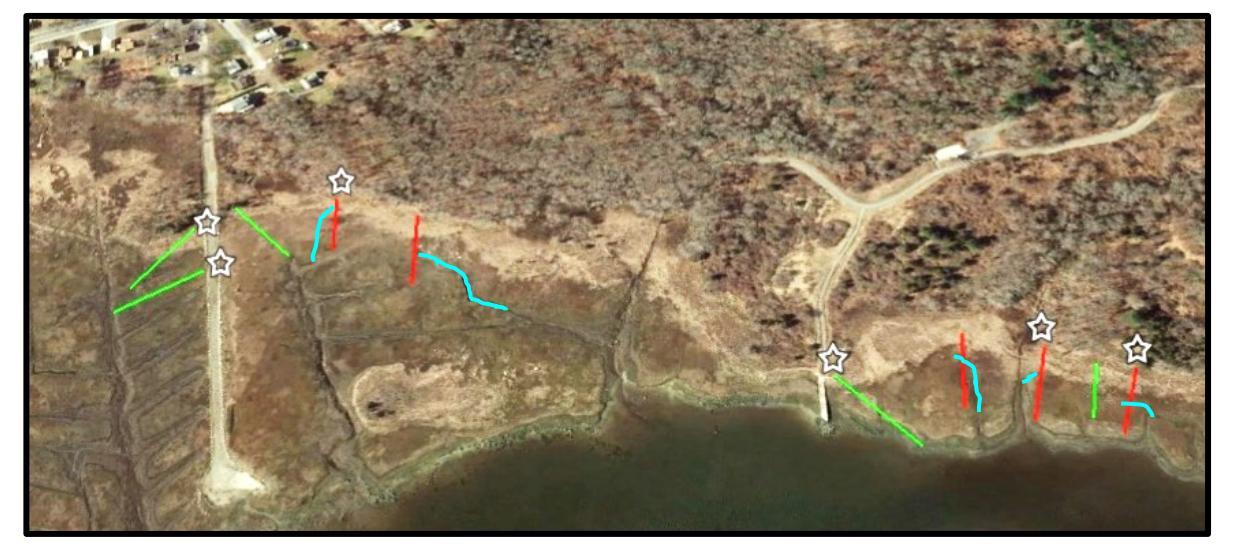
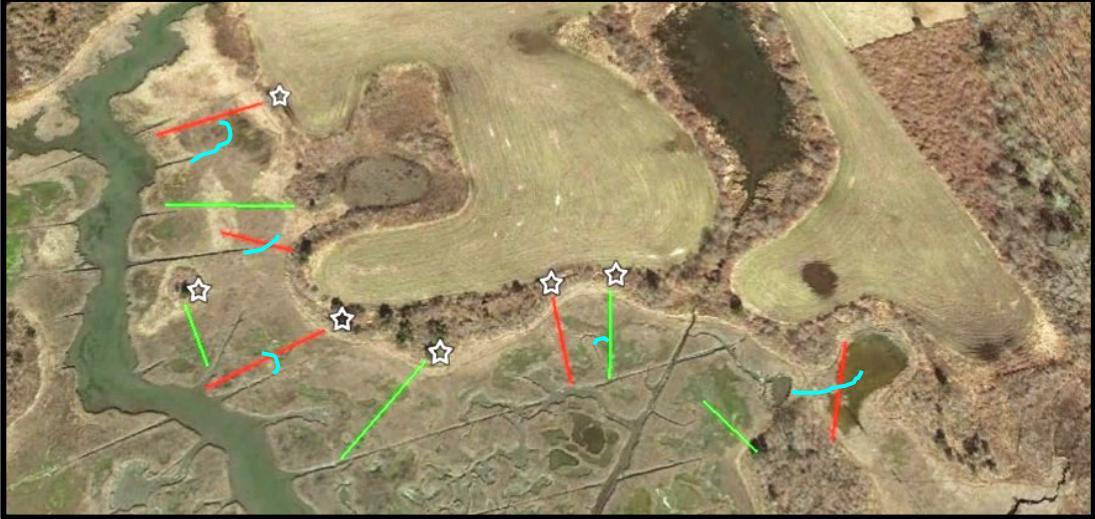
Pilot runnelling technique as SLR mitigation tool

- Runnels are small channels to create tidal connection between shallow water on marsh surface and a creek, draining root zone
- Pre-monitoring in 2020, runnels created Oct 2020 Feb 2021, post-monitoring thru 2023
- Partnership with Woodwell, Save the Bay RI, BBNEP, USGS, Bristol County Mosquito Ctl

- Monitoring:
 - Vegetation metrics
 - Photo stations
 - Elevation
 - Soil characteristics
 - Water level
 - Shear strength
 - Decomposition
